Risk of the trees and the stumps to the embankment dam safety. Experimental study

J. Laasonen

Fortum Power & Heat Oy, POB 100, FI-00048 Fortum (Espoo), Finland

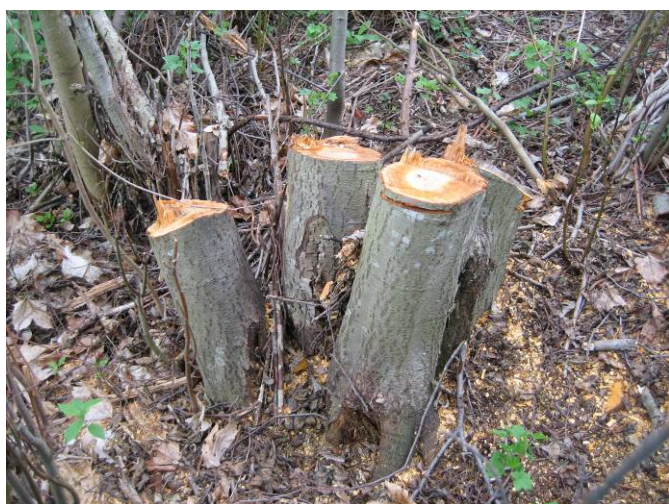
Figure 1: The willow stumps at the embankment slope.

The trees of the first part were goat willows, willows and alders. The trees were cut during autumn 2009. The stumps of the willows were in 2-4 tree groups and having a diameter of 100-200 mm, max. 300 mm (Figure 1). The black alder and rotten alder were removed at the lower end part. The stumps were removed with backhoe excavator. The bucket was lifted and twisted (Figure 2).

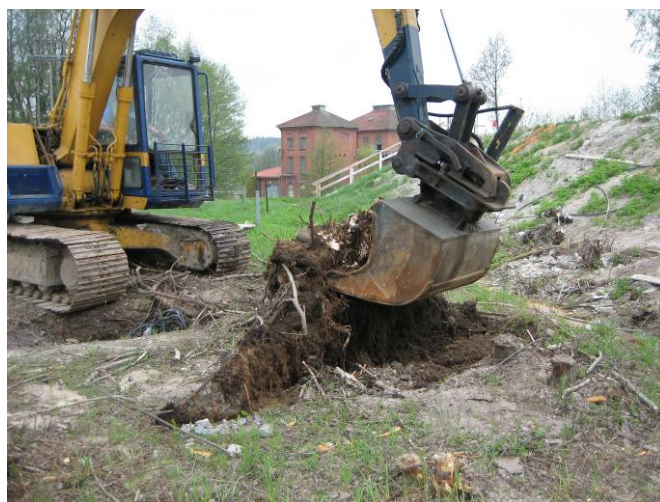
Figure 2: The stump pull test at Peltokoski embankment dam.

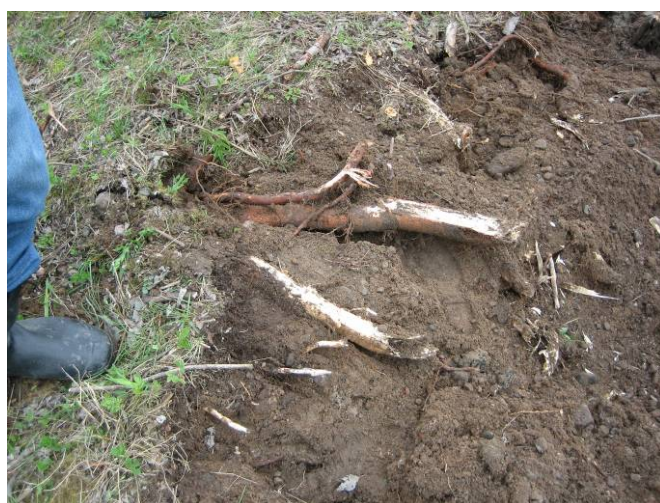
Figure 3: The root system was parallel to the surface.

The shape and diameters of the root system were mapped and measured. Biggest roots had a diameter of 80 mm. Total lengths of the individual roots were not measured. However some roots had a diameter of 45 mm at 1.5 meter distance from the center of the stump. The root system was parallel to the surface profile, not going deeper in the soil (Figure 3). The stump and the root system of the rotten alder were almost totally decomposed.

The root system of the conifer trees (pine, spruce) remain unchanged in the embankment slope, but the root system of the deciduous trees (birch) are decomposed. Therefore it is recommended that the stumps of the deciduous trees are removed and filled with dam material, when they are cut. The stumps of the conifer trees may be left, if they are situated in the upper part of the slope.

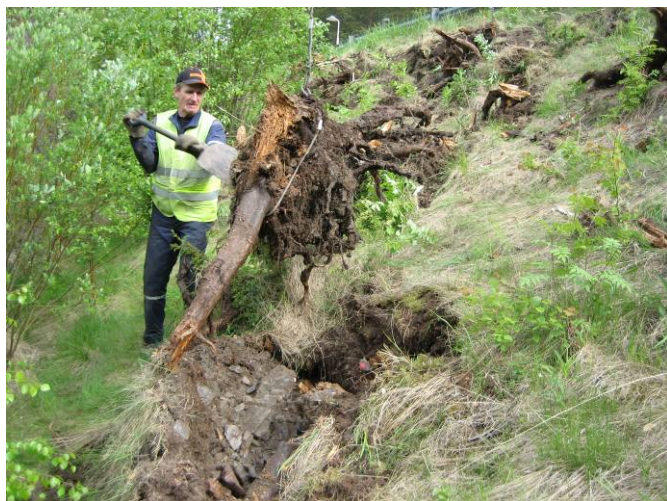
Figure 4: 20-year old pine stump was removed with wire rod at Nuojua.

individual root varied from 80 to 200 mm. The roots were in good condition although they have stayed 20 years in the ground. There were hardly any signs of rot. The stumps were tightly connected to the slope, which indicates good resistance against winds (Figure 4).

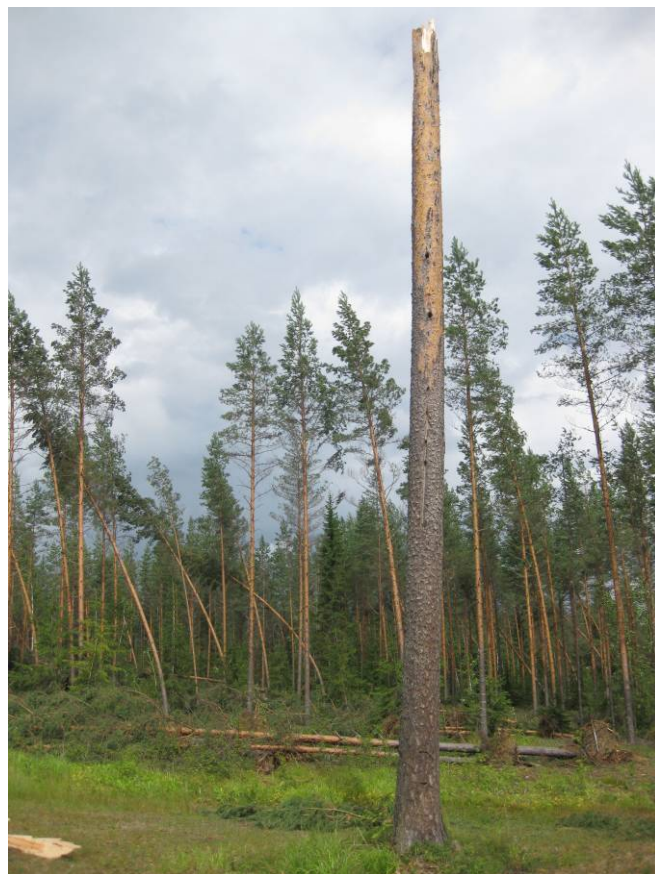
Figure 5: The top of the pine tree has snapped.

The **pine** trees have fallen totally with the root system or the top was snapped leaving the trunk in its place (Figure 5) or the trees remained bended (lodged tree). It was observed that the primary root (tap) of the fallen trees was broken.

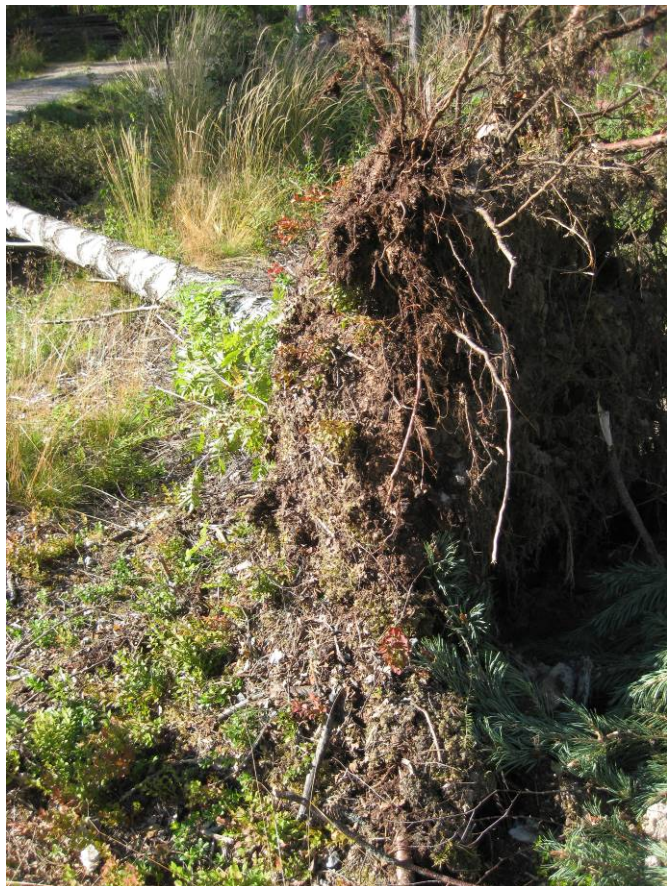
The **spruce** trees have fallen totally with the root system or the top was snapped leaving the trunk in its place. The **birch** trees have fallen totally with the root system (Figure 6) or the trees remained bended (lodged tree).

Figure 6: Fallen birch tree.

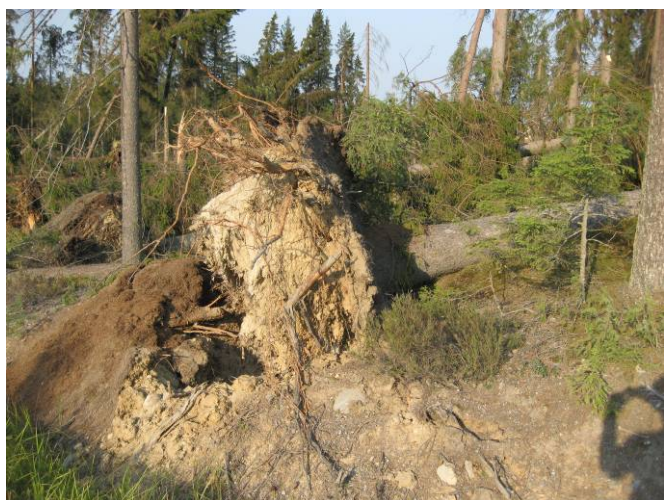
Figure 7: Fallen spruce tree with thick soil layer.

The soil density together with the extent of the root system has an influence in cohesive or granular soil. The root system of some fallen spruce took a thick soil layer of couple m^3 of silt/sand ground (Figure 7).

It may be concluded that the size of the tree at the embankment dam shall be limited based on the observation that big falling spruce in the embankment dam slope may grab thick soil layer together with the root system.
