Internal Erosion and Duration of Grouting Works. Case History of a Small Embankment Dam

Abstract

Peltokoski hydropower plant in River Mustionjoki, Southern part of Finland, was reconstructed in 1950-1951 and the head of the power station was increased. A low head hydropower plant comprises right embankment dam, a spillway, a power station, a buttress dam and left embankment dam. The embankment dams are homogenous moraine dams and they are mainly founded on moraine. A wooden sheet piling is installed inside the highest part of the embankment dams. The dam belongs to Consequence Class 2 and the dam breach will not cause any loss of life. Also the damages to third person's property are small.

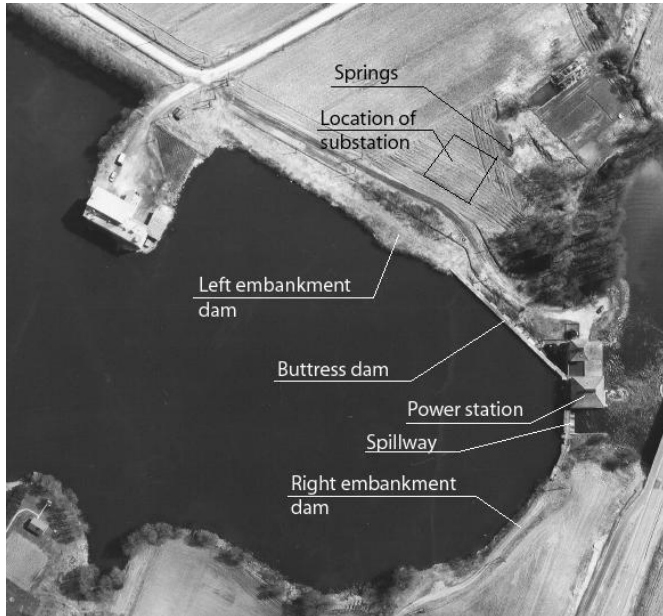
At Peltokoski there has been two springs, one from the beginning of the reconstruction and the other from 1980's. These springs were situated approx. 60 meters from the left embankment dam (Figure 2).

Figure 2: Aerial photograph from 1980's.

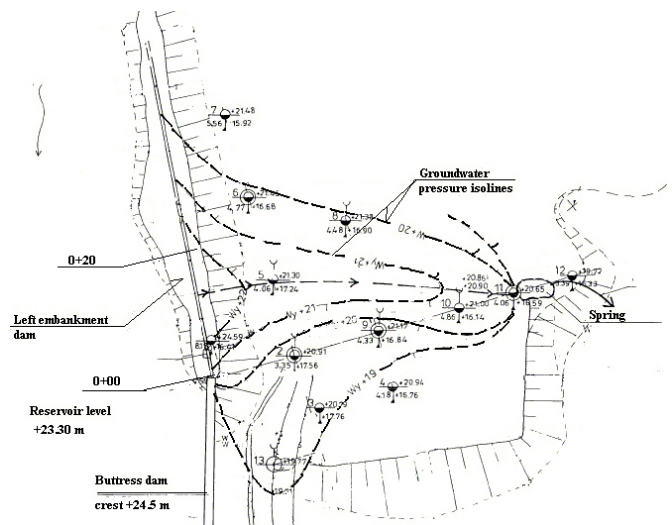
Highest groundwater pressures were measured approx. 15 meters from the end of the butress dam. The area of high pressures is formed perpendicular to embankment dam towards to the spring. The groundwater pressures in the silt/fine sand layer were approx. 60 cm above the ground elevations.

Figure 3: The results of the groundwater pressure measurements (IPT, 1984).

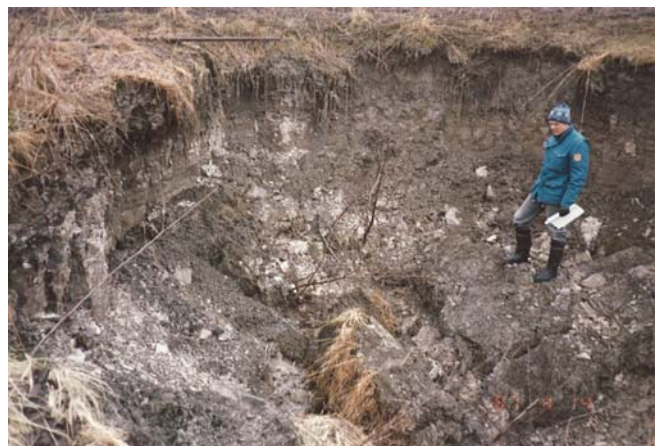
In late winter 1987 the spring collapsed approx. 60 meters from the left embankment dam. A large sink hole of 3 meter deep and a settlement of 29 cm at the dam crest were formed (Figure 4). The collapsed bank was repaired by constructing inverse filter with stones on the surface. Two Thompson overflow weir were constructed behind the inverse filter. Total leakage was 35 l/s. The water was clear without any sediment suspension.

Figure 4: A large sink hole was formed due to the internal erosion in 1987.

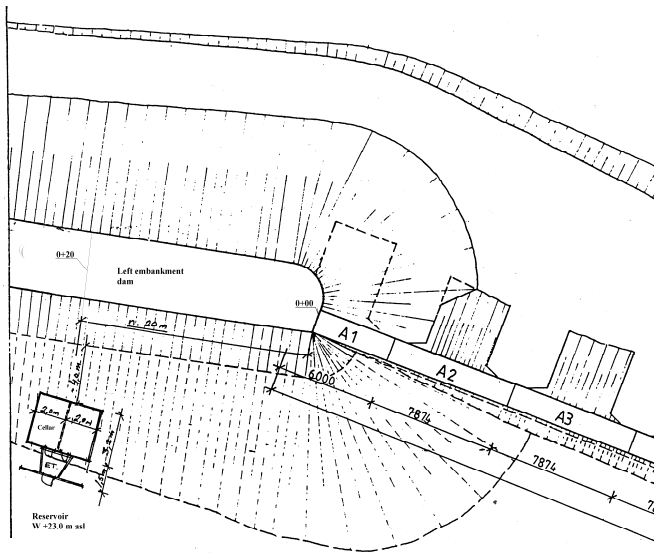
The diver study was carried out in November 1987. A cellar building was left in the upstream dam toe during the construction (Figure 5). The building has a porch of 1.5×2 m² and two cellars each of 2×3.2 m². The building was situated approx. 20 meters from the butress dam. The roof of the building was in the depth of 4 meters. The cellar has had a wooden floor, which has decayed. Hard clay was found under the structures and any water flow could not be observed. It was concluded that the building has not any influence to the leakage.

Figure 5: A cellar building is situated at the toe of the left embankment dam (1987).

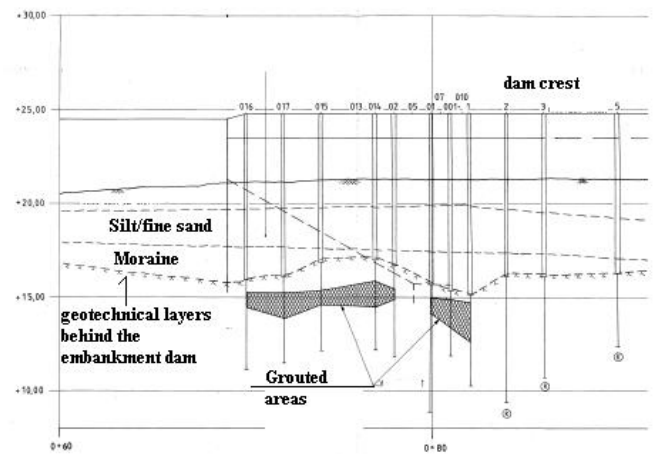
The leakage area at the chainage 0+13 - 0+45 were detected with a georadar. The actual depth of the leakage could not be confirmed with the georadar. Two meters deep fractured rock zone was detected at the depth of 12 meters during the drilling. The connection between the fractured zone and the leakage outlet could be verified with a tracer. The travelling time of the tracer from the fracture rock to the inverse filter was 17 minutes.

The leakage flow due to the grouting works decreased from 35 l/s to 1.2 l/s.

Figure 6: The grouting works in 1988.

The grouting works of the fractured rock were done with polyurethane (1'330 kg), cement (25'600 kg) with bentonite (8'000 kg) and with filler (52'800 kg). Total amount of the grouting mass was 101 m³.

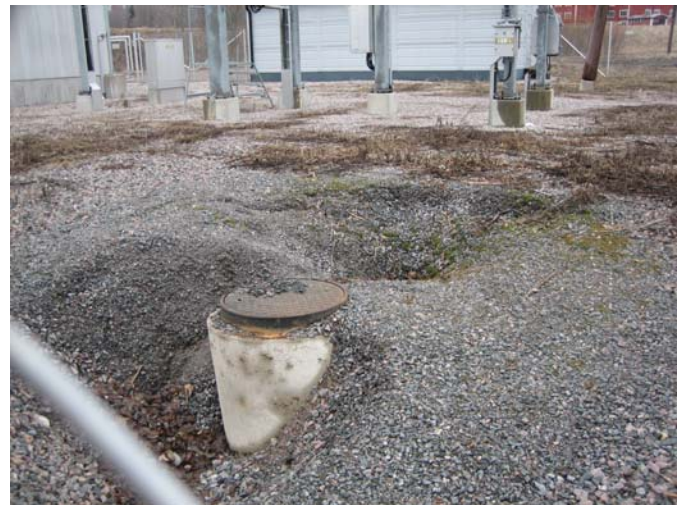
A substation was constructed above the leakage path without any consultations in 1994. The substation is constructed on the shallow foundation. The crushed stone layer of 250 mm is under the concrete foundation. The area under the substation is pressurised approx. to the ground level. The sinkholes are refilled appearing. There has been tendency that the sinkholes are slightly moving towards the embankment dam (**Figure 7**).

Figure 7: The sink holes at the substation on March 21, 2007.

The backward erosion is observed and the sinkholes are approaching the substation structures. At the moment, this internal erosion through the foundation and the silt/fine sand layer is not a dam safety problem, but it is a problem for the electrical distribution. If a new sinkhole will cause closing down of the electrical distribution, the costs of the bad publicity are many times higher than the structural damages. The investigations continue and the alternatives for repairing the leakage are studied. Also the preparedness activities are done e.g. control inspections, the masses are reserved at the site.

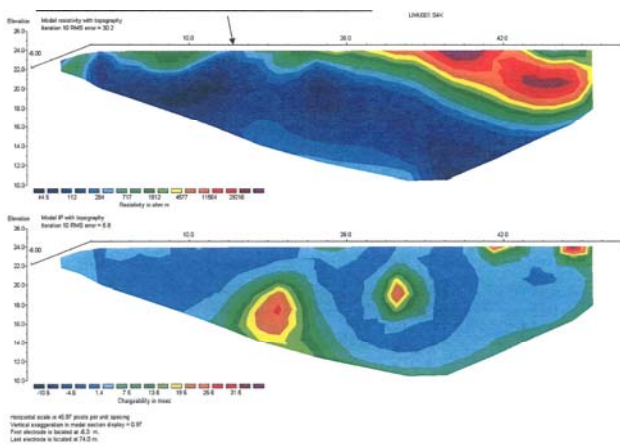
indicate that there are two weak spots: one at the foundation approx. at PI 15+00 - 25+00 and the other at the dam body at approx. PI 30+00. The grouting of the bedrock started in late Autumn 2009, but the grouting works have to be stopped due to the hard winter conditions.

Figure 8: Preliminary results of electrical profiling. The upper figure is the resistivity, which corresponds the density of the soils, and the lower figure is chargeability, which corresponds the leakage (VTT, 2009).
