Internal Erosion and Duration of Grouting Works. Case History of a Small Embankment Dam

Abstract

Peltokoski hydropower plant in River Mustionjoki, Southern part of Finland, was reconstructed in 1950-1951 and the head of the power station was increased. A low head hydropower plant comprises right embankment dam, a spillway, a power station, a buttress dam and left embankment dam. The embankment dams are homogenous moraine dams and they are mainly founded on moraine. A wooden sheet piling is installed inside the highest part of the embankment dams. The dam belongs to Consequence Class 2 and the dam breach will not cause any loss of life. Also the damages to third person's property are small.

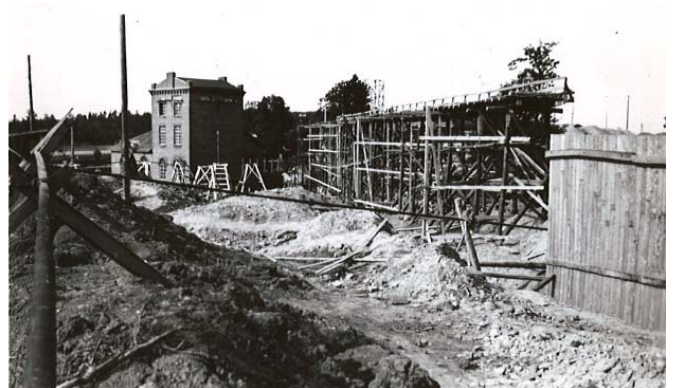
Figure 1: The construction of the left buttress and embankment dam. The wooden sheet piling of the embankment is on the right hand side, August 1950.
